RV Inspection Report

Texan RV Park, 9024 US HWy 175 W, Athens, TX 75751

Inspection Date / RV Model:
November 18, 2025 – 2022 Winnebago Travato BU259GL

Rolling Rabbit RV Repair LLC

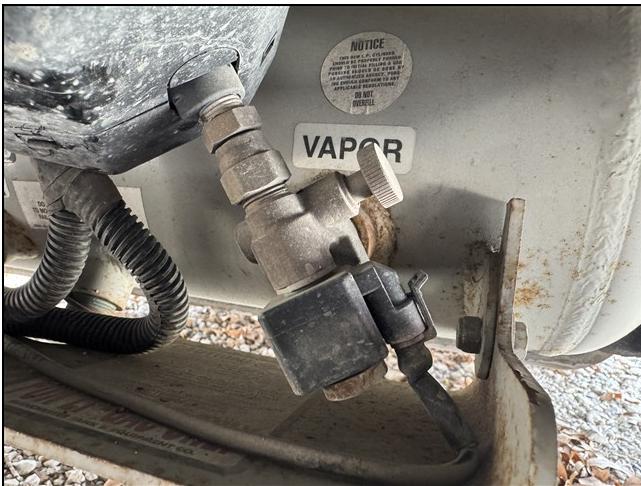
ASME Tank Outlet Port

No accessible LP quick-disconnect was found to perform the Propane System Leak Test. This is a life safety issue. It is recommended this be further evaluated by a qualified RV technician.

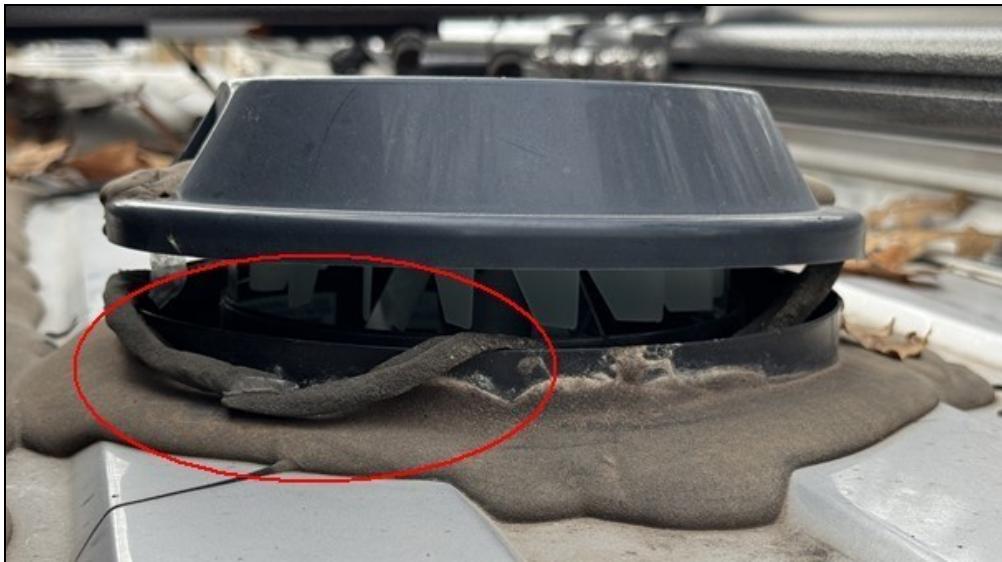
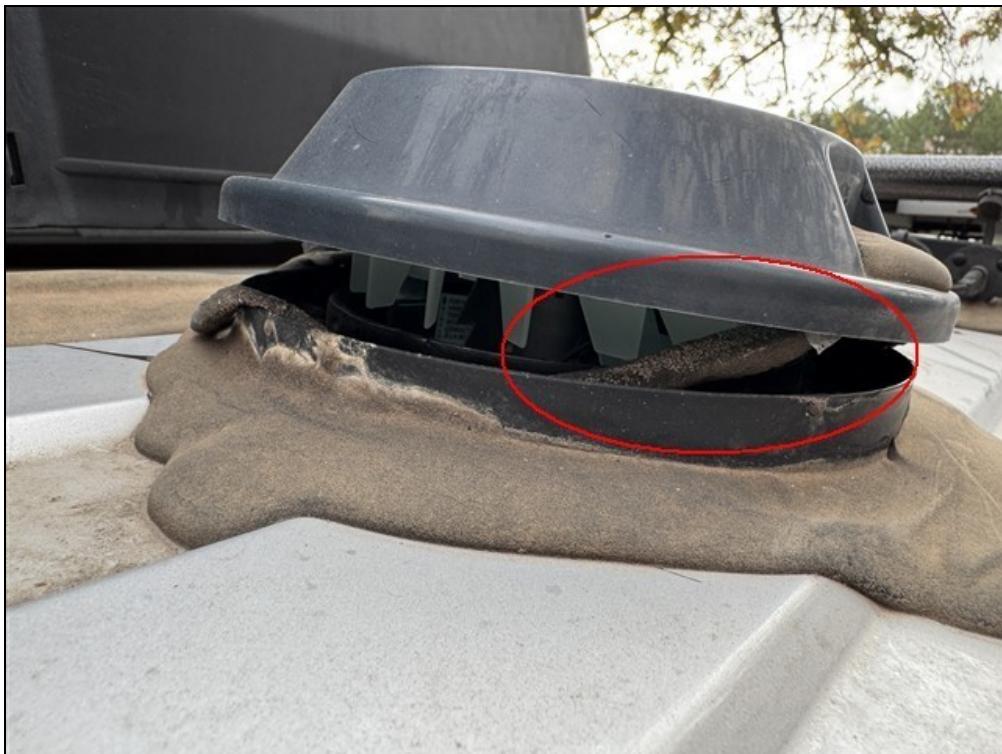
The exterior bathroom vent cover has a loose foam gasket. It is recommended this be further evaluated by a qualified RV technician.

The exterior bathroom vent cover has a loose foam gasket. It is recommended this be further evaluated by

a qualified RV technician.

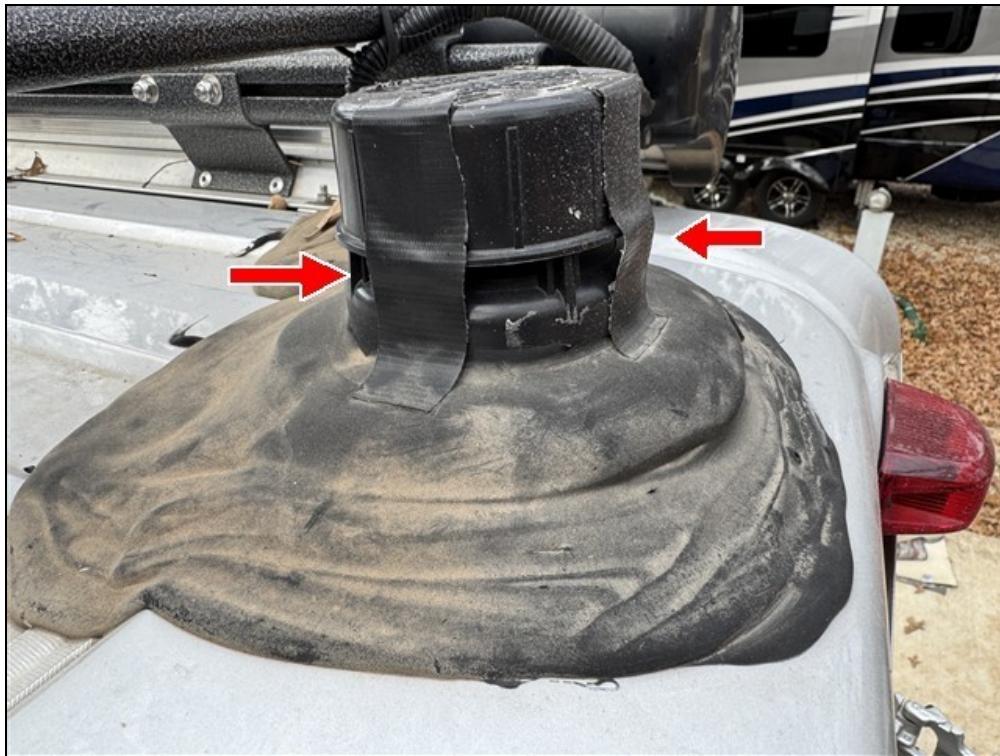
(1) The toilet vent cover is taped on with duct tape. This is a life safety issue. It is recommended this be further evaluated by a qualified RV technician.

(1) The toilet vent cover is taped on with duct tape. This is a life safety issue. It is recommended this be

further evaluated by a qualified RV technician.

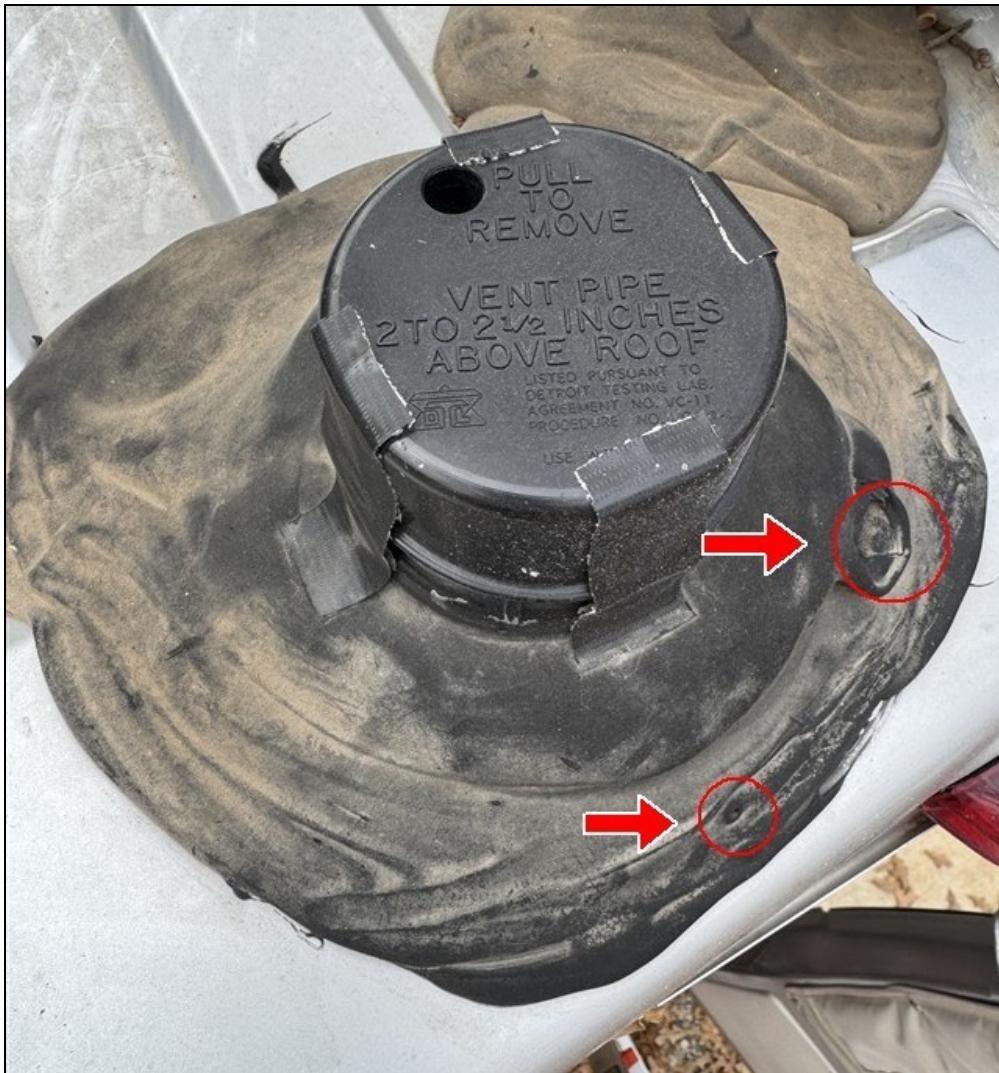
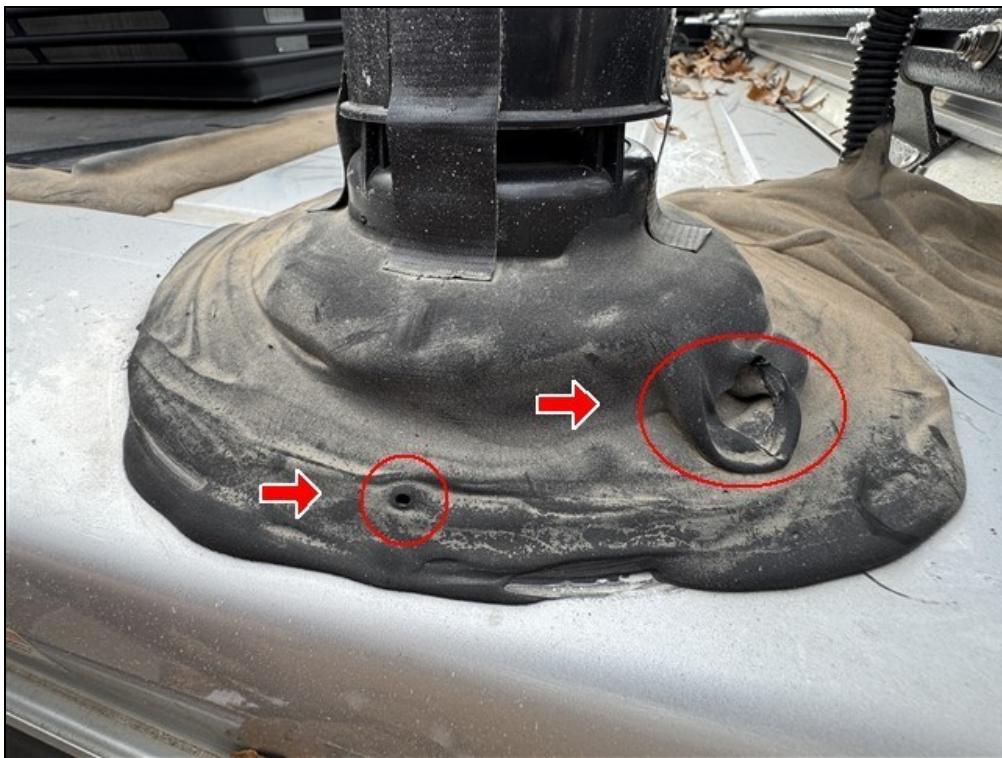
(2) The sealant around the toilet vent cover has pin holes. This could cause water intrusion. This is a life safety issue. It is recommended this be further evaluated by a qualified RV technician.

(2) The sealant around the toilet vent cover has pin holes. This could cause water intrusion. This is a life

safety issue. It is recommended this be further evaluated by a qualified RV technician.

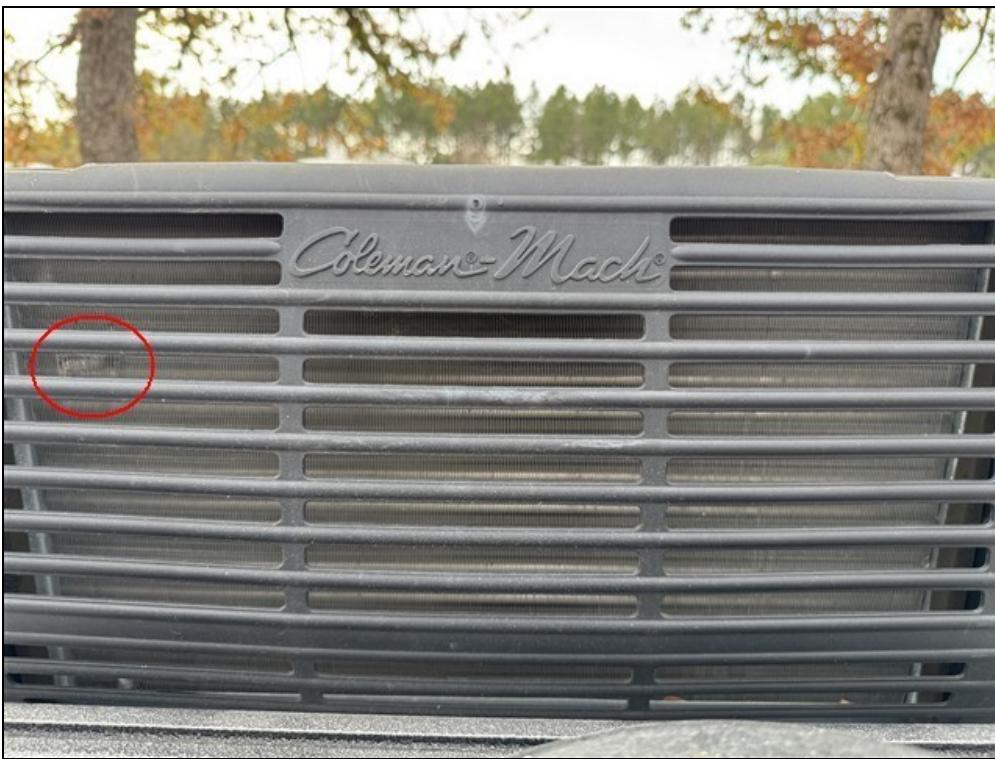
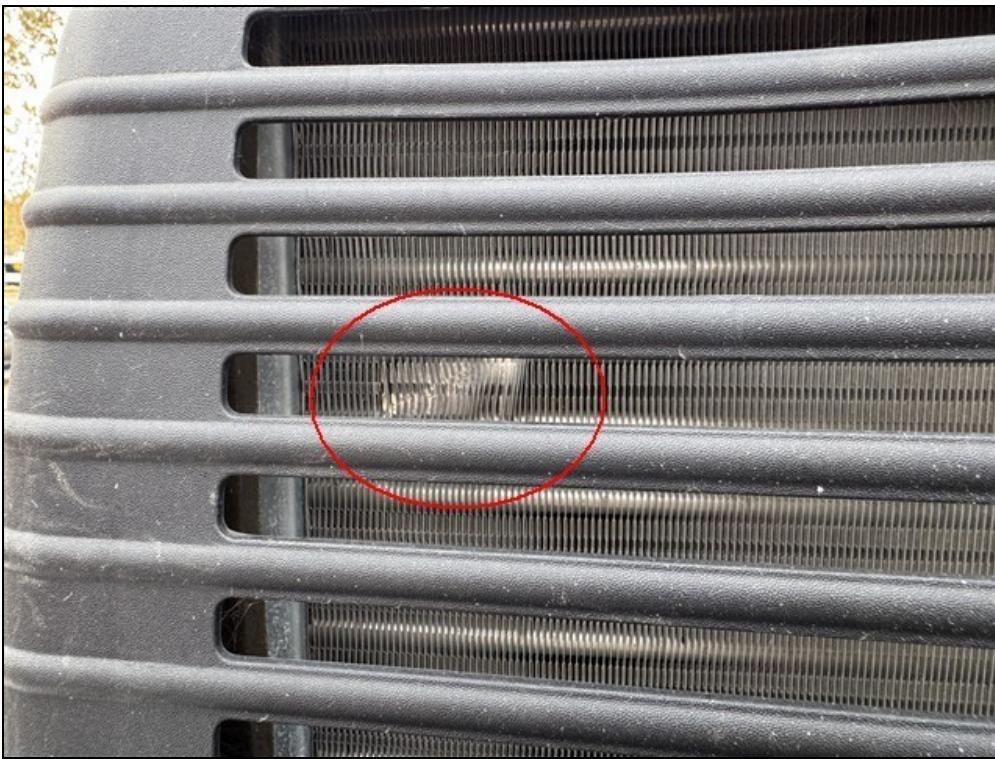
There is a small damaged section on the rear streetside section of the air conditioner coils.
